U.S. 101 MP 142.48 HARLOW CREEK (WDFW ID 990548): Preliminary Hydraulic Design Report

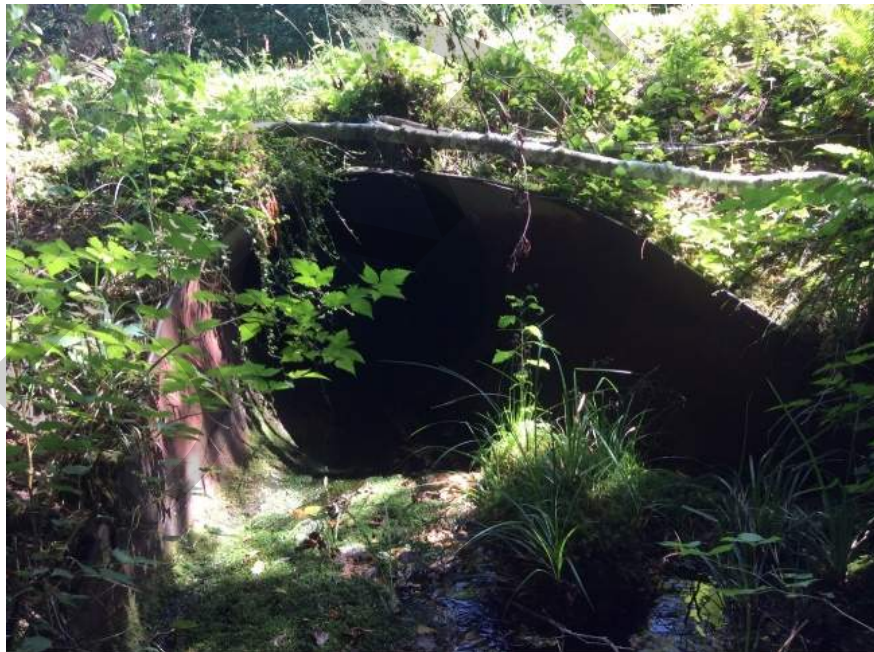
The culvert itself is a 4-foot-wide CMP mitered to slope (Figure 20). The culvert inlet is perched approximately 4 inches above the channel bed.

Figure 20: Culvert inlet

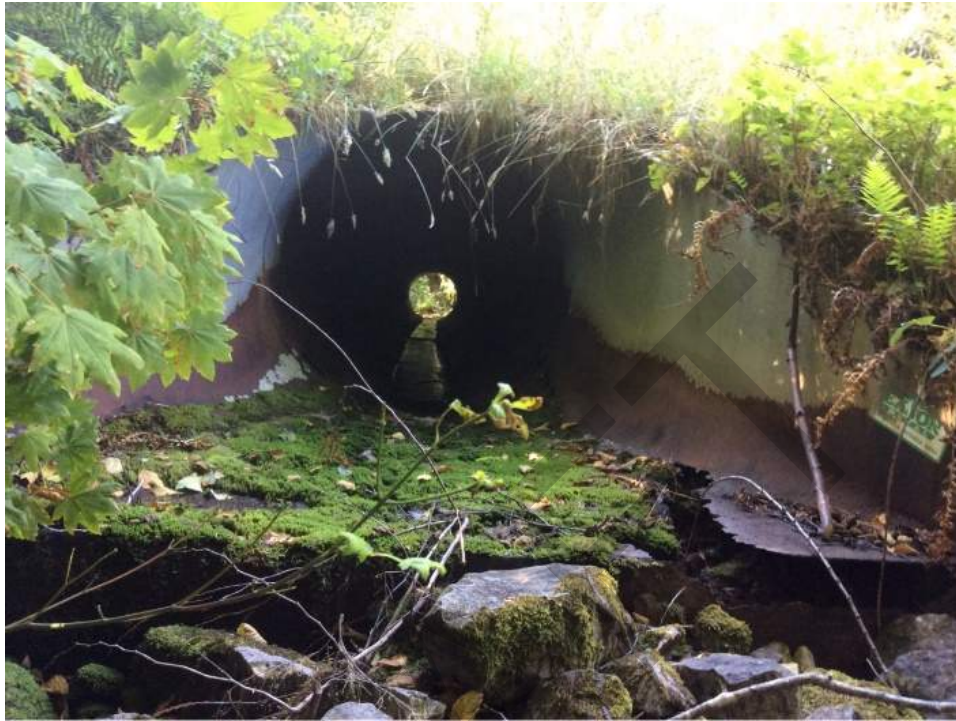
At the outlet of the culvert, there is an approximate 6-inch drop from the culvert apron below to riprap which lines the channel bed (Figure 21). The existing metal apron is failing due to corrosion and past undermining at the transition to the channel. Riprap is present in the channel for 15 feet downstream of the culvert.

Figure 21: Culvert outlet

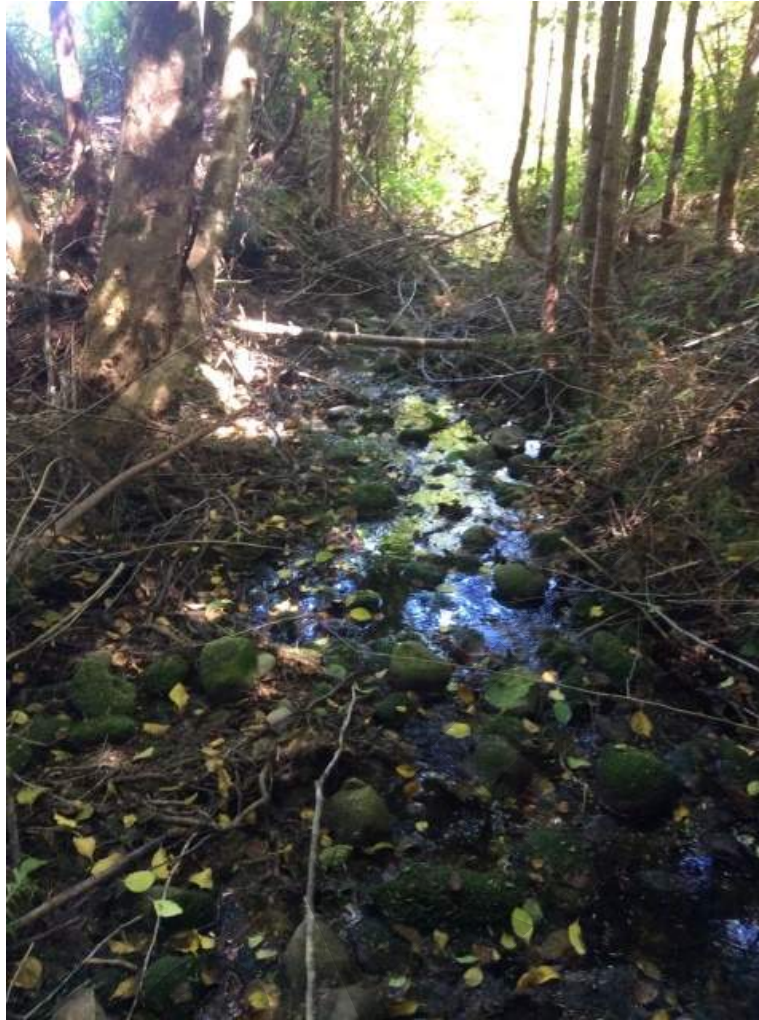
The reference reach begins downstream of the racked LWM roughly 45 feet downstream from the culvert outlet. (Figure 23). The left bank is about 1 to 2 feet tall, and the right bank is about 2 to 3 feet tall. The left bank floodplain is flat before sloping up to the roadway. The right floodplain is moderately sloped. Roots of trees form the banks periodically on both sides of the channel. The channel itself is 4 to 5 feet wide, and entrenched within its near vertical banks, owing to the influence of the undersized culvert opening. This channelized section is armored and relatively stable, as evidenced by the establishment of moss on top of streambed cobbles.

Figure 23: Reference reach

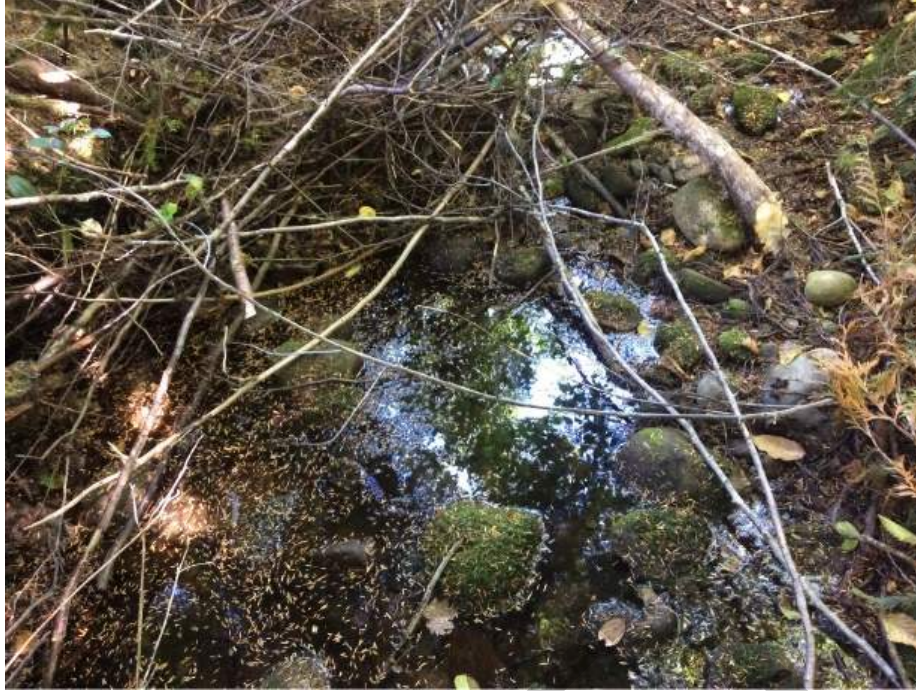
All three BFWs were taken through this section of stream. BFW measurements and photographs are provided in Section 2.8.2. The channel substrate is gravels and cobbles, and a pebble count was performed here as well (Figure 24 and Figure 25). Trees are present on the banks and in the floodplains, but there is little brush. The reference reach selected is most likely influenced by the culvert discharge, but a superior reference reach was not found due to the incised channel banks throughout the channel both upstream and downstream.

Figure 24: Reference reach substrate and pebble count location

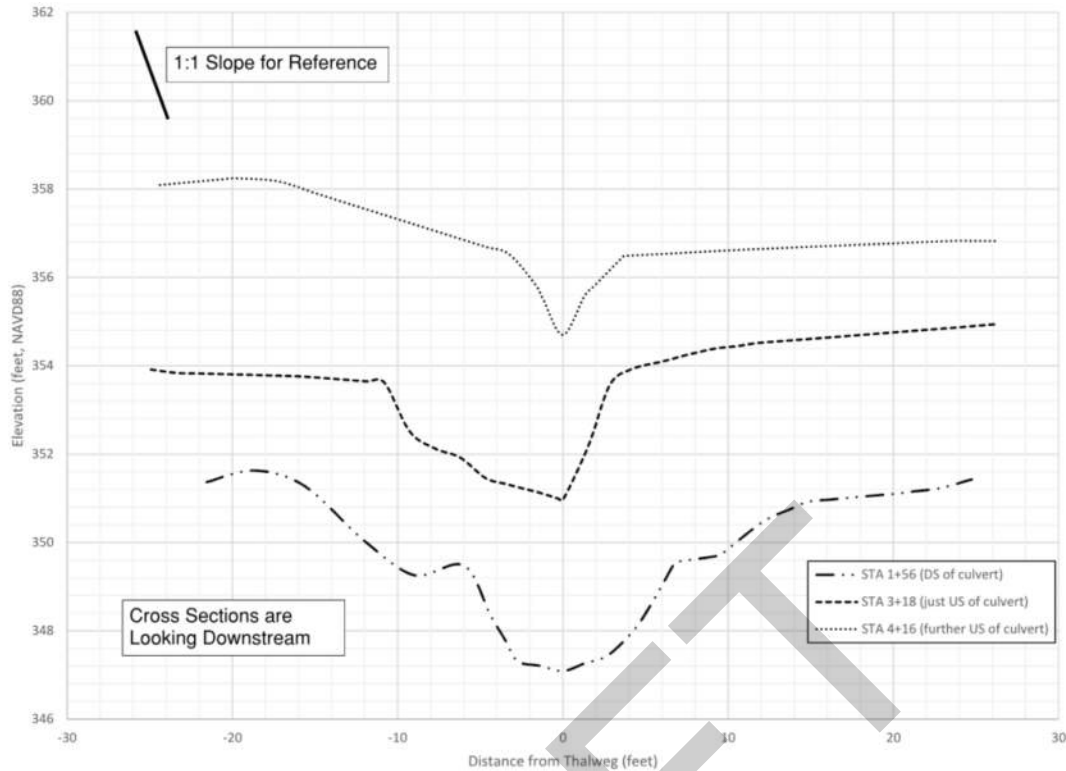
Figure 31 shows typical detailed cross sections at the project site developed from the WSDOT survey: one upstream of the U.S. 101 crossing, one just upstream of the culvert, and one downstream of the culvert. The upstream-most cross section shown (STA 4+16) is narrow, with a wide, flat floodplain that is often wetted due to the abundance of LWM spreading flow out of the channel. The cross section immediately upstream of the culvert (STA 3+18) includes a large scour pool in front of the culvert as all flow converges at the culvert inlet approach. The downstream-most cross section shown (STA 1+56, in the reference reach) has the widest channel shape with a defined thalweg and terraced floodplains. The channel geometry within the reference reach (STA 1+56) provides the best-available reference cross section for the design of the proposed crossing to provide adequate depth at low-flows and an accessible floodplain surface near channel-forming flows.

The width-to-depth ratio is measured at the reference reach cross section at STA 1+56 and is approximately 6:1. The channel averages 1 to 1.5 feet deep. The channel evolution stage was evaluated in the reference reaches and estimated to be in Stage I of the Channel Evolution Model (Schumm et al. 1984).

Figure 31: Existing cross-section examples

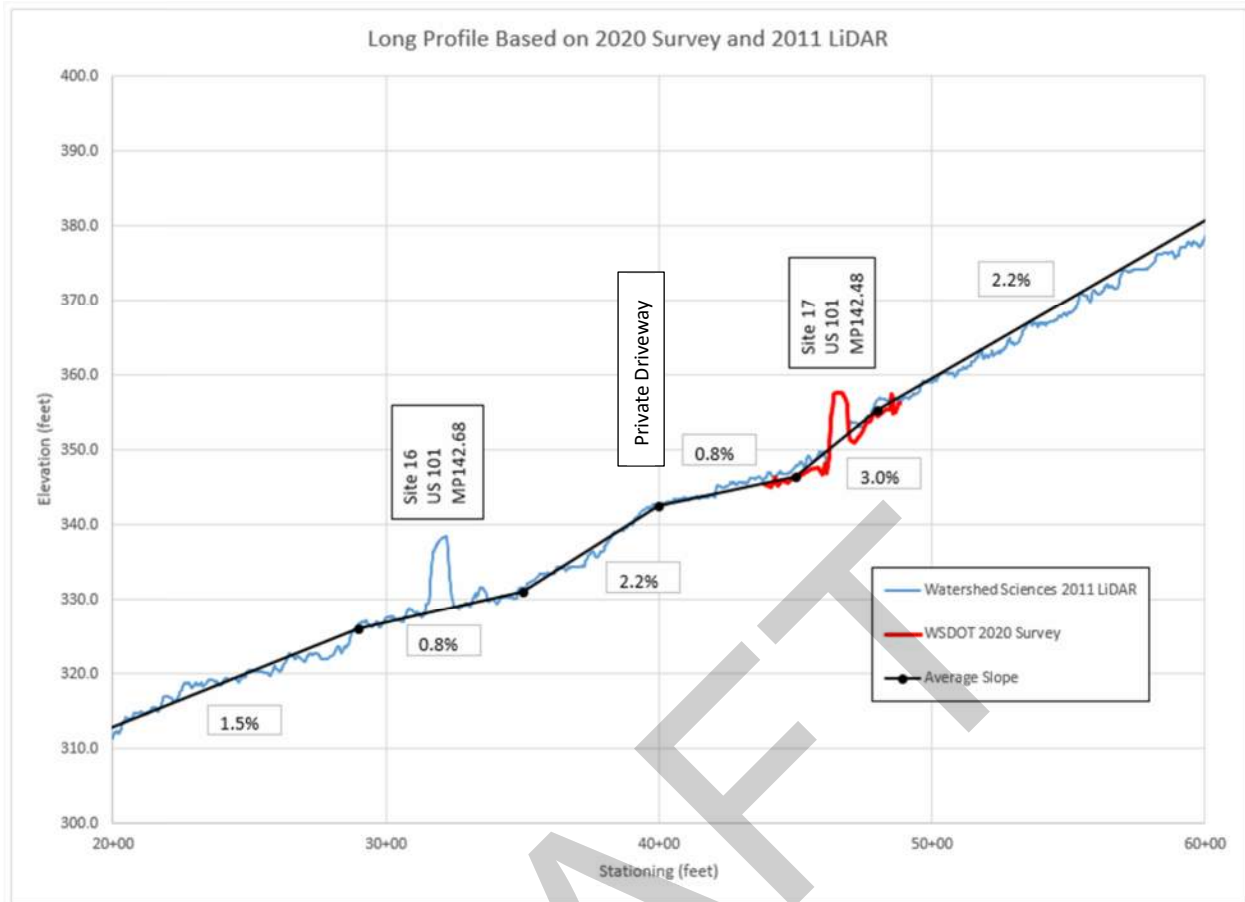
Downstream, the channel has both confined and unconfined stretches. From the culvert outlet to approximately 110 feet downstream, the channel is confined and entrenched within defined banks. At this point, the left bank becomes low and terraced and flow spills out into the floodplain, creating an unconfined channel. Throughout the entire downstream reach, the average slope of the surveyed extent is approximately 1 percent below the culvert outlet. The existing drop at the culvert outlet will be removed, including scour protection rock, in proposed conditions by daylighting the channel into the downstream bed elevations at a constant slope, this armored downstream reach is stable. Sediment supply, composed primarily of fines with gravel, is deposited near the existing log jams. Sediment yield potential within the basin may fluctuate with changes to land use and land cover but does not pose a significant risk of aggradation in the project reach.

Figure 39: Watershed-scale longitudinal profile with average slopes

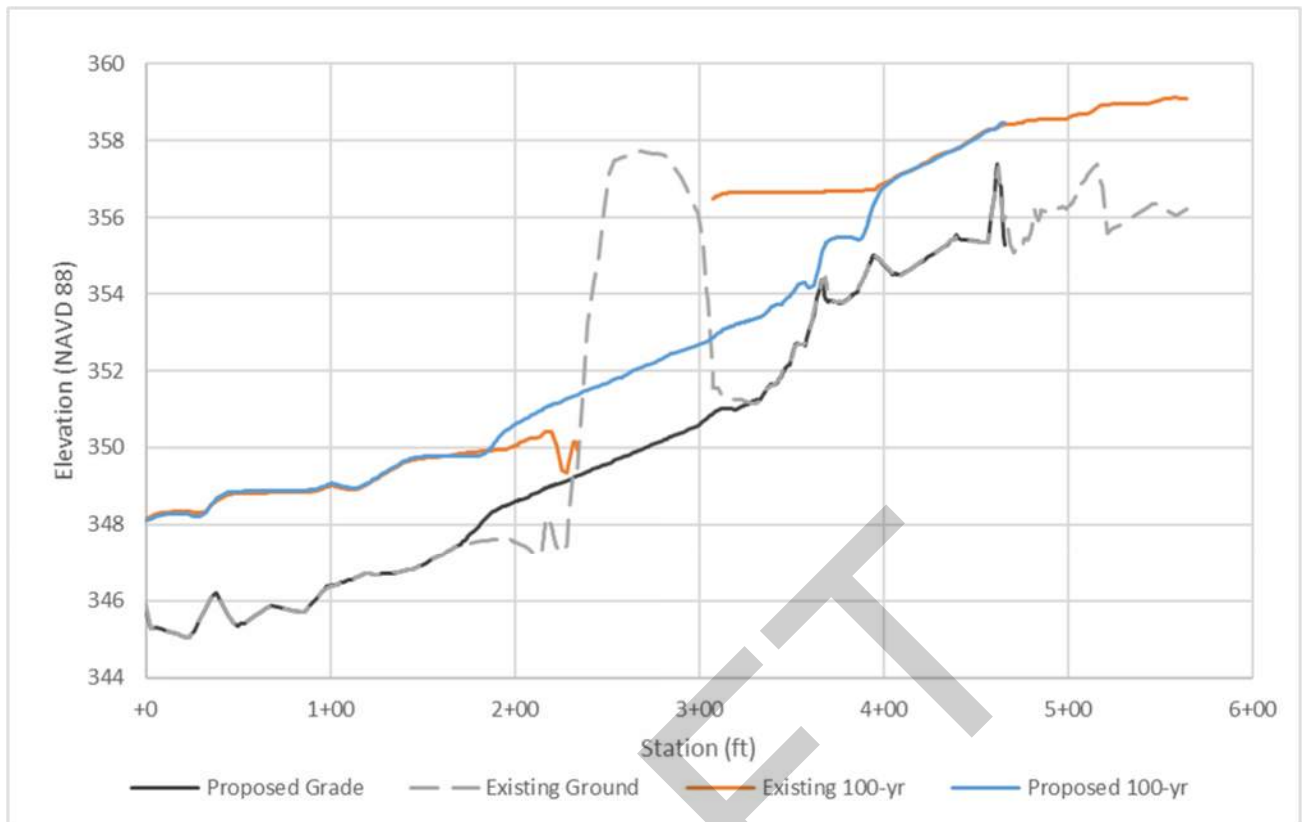
Immediately downstream of the culvert, channel regrading for proposed conditions causes a rise by as much as 1.9 feet in water surface near STA 2+28. The local water surface rise is a result of the fill in the scour hole downstream of the existing culvert outlet. Past the outlet, the water surface change varies between no change and less than a 0.1-foot rise from the existing to proposed conditions.

Figure 76: Existing and proposed 100-year water surface profile comparison
